The Gasket

Thermo Donut © System

Feb 2020

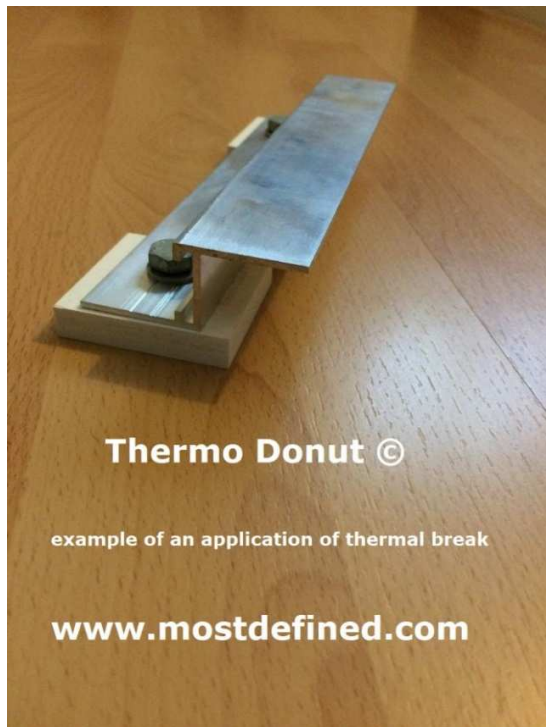
Thermo Donut ©

example of an application of thermal break

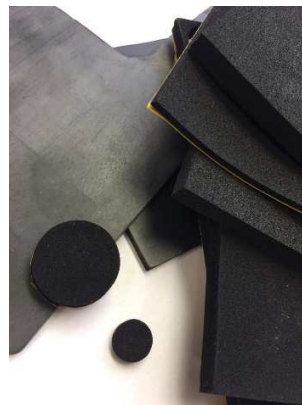
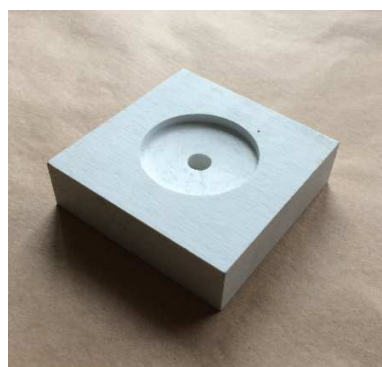
After many calculations and tries, the optimal material, diameter, depth and hardness of the gasket as well as the best form, dimensions and angles of the pit in the thermal break were determined. The design phase was completed. Afterwards we carried out following inhouse tests:

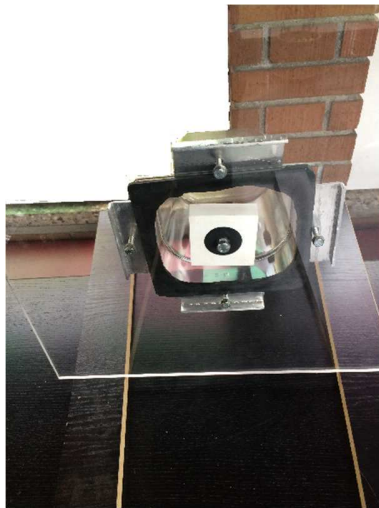
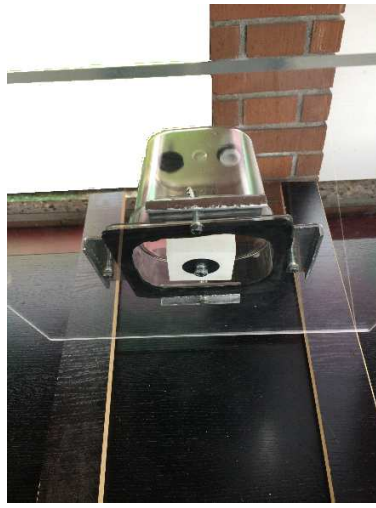
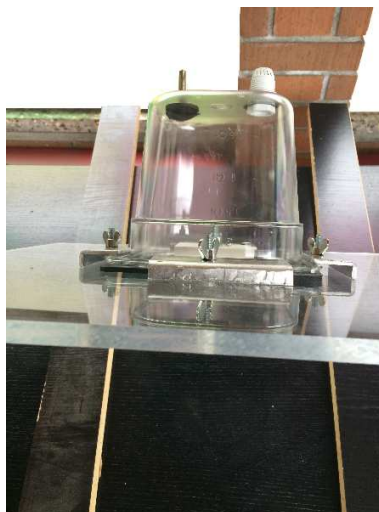
After seeing that the gasket works, we wanted to carry out tests with water and pressure. For this we put a waterproofed and transparent hood onto the glass plate (over the thermal break that is fixed by a fastener which goes through the plate, hole in the plate with "notch" so the hole is for sure not sealed!). We filled water into the hood and added pressure (test at ca. 4 °C).

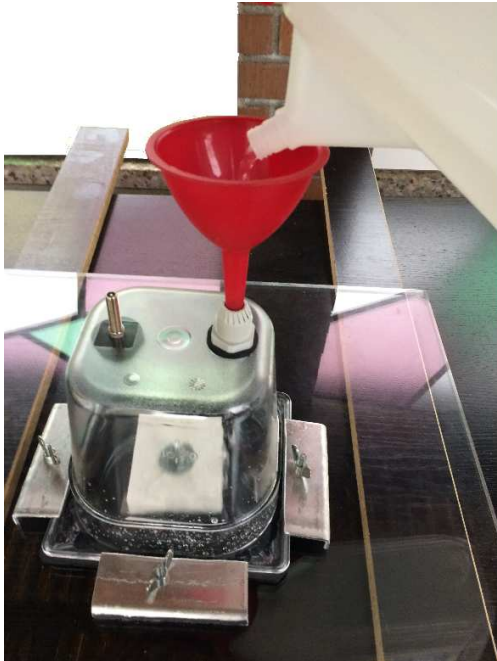
View from underneath the glass plate (view through the glass plate, only the fastener goes through the plate)

First we ran a test without gasket (for comparison). Without pressure it was even after 30 Min. (surprisingly) dry. After that time it became wet. And then with pressure (100 kPa) it was leaking badly.

After that, we ran tests with gasket (start Dec 20, 2019). For the first week we ran the test every day and then every week (each time one test run without pressure and three test runs with pressure (one minute apart), test runs each time minimum 20 Min. after filling water into hood).

At all test runs with gasket the fastener (anchor) at the underside of the glass plate remains dry.

Result: dry, Success!

In order to see in addition the long-term effects, we are repeating the tests (tests are still ongoing). And we also run tests with a carved glass plate (simulation of torn borehole).
